- Tree Protection Plan -

**PNW HOME BUYER - IGOR GORBUN SUBDIVISION**

308 23<sup>rd</sup> Ave.  
Milton WA 98354

Prepared for: PNW Home Buyers, LLC  
Prepared by: Washington Forestry Consultants, Inc.  
Date of Report: November 15, 2019

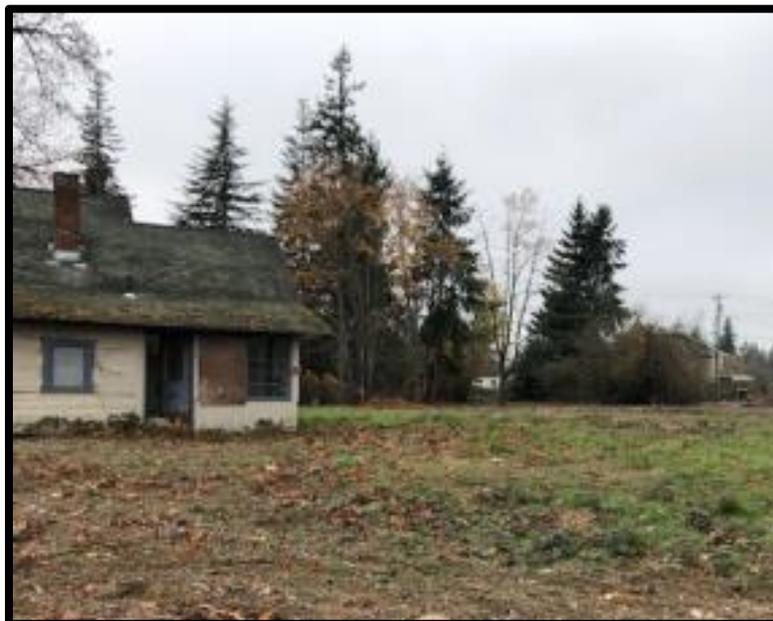
There are 12 trees in this cover type that range in size from 9.5 to 38 inches DBH. Tree condition ranges from 'Very Poor' to 'Fair,' with half (6) of the trees described as being in 'Fair' condition. These 12 trees are described individually in Table 1 below.

**Photo 1.** View of trees in Cover Type I

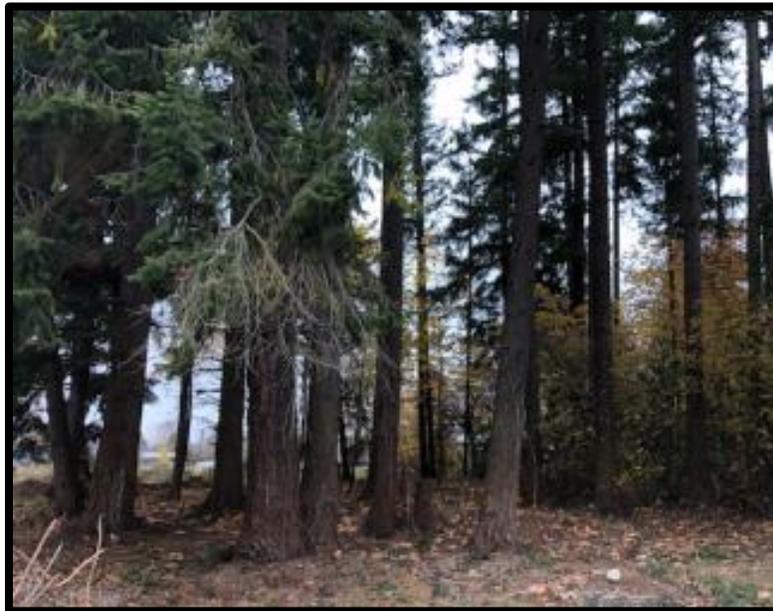
Forest Cover Type II is a mature stand of Douglas-fir with some smaller bigleaf maple trees in the understory. There are 51 significant trees in this cover type ranging in size from 7 to 50 inches DBH. Tree condition ranges from ‘Very Poor’ to ‘Good,’ with most trees described as being in ‘Fair’ condition or better. These trees are summarized in Table 2 below.

**Photo 2.** View of trees in Cover Type II

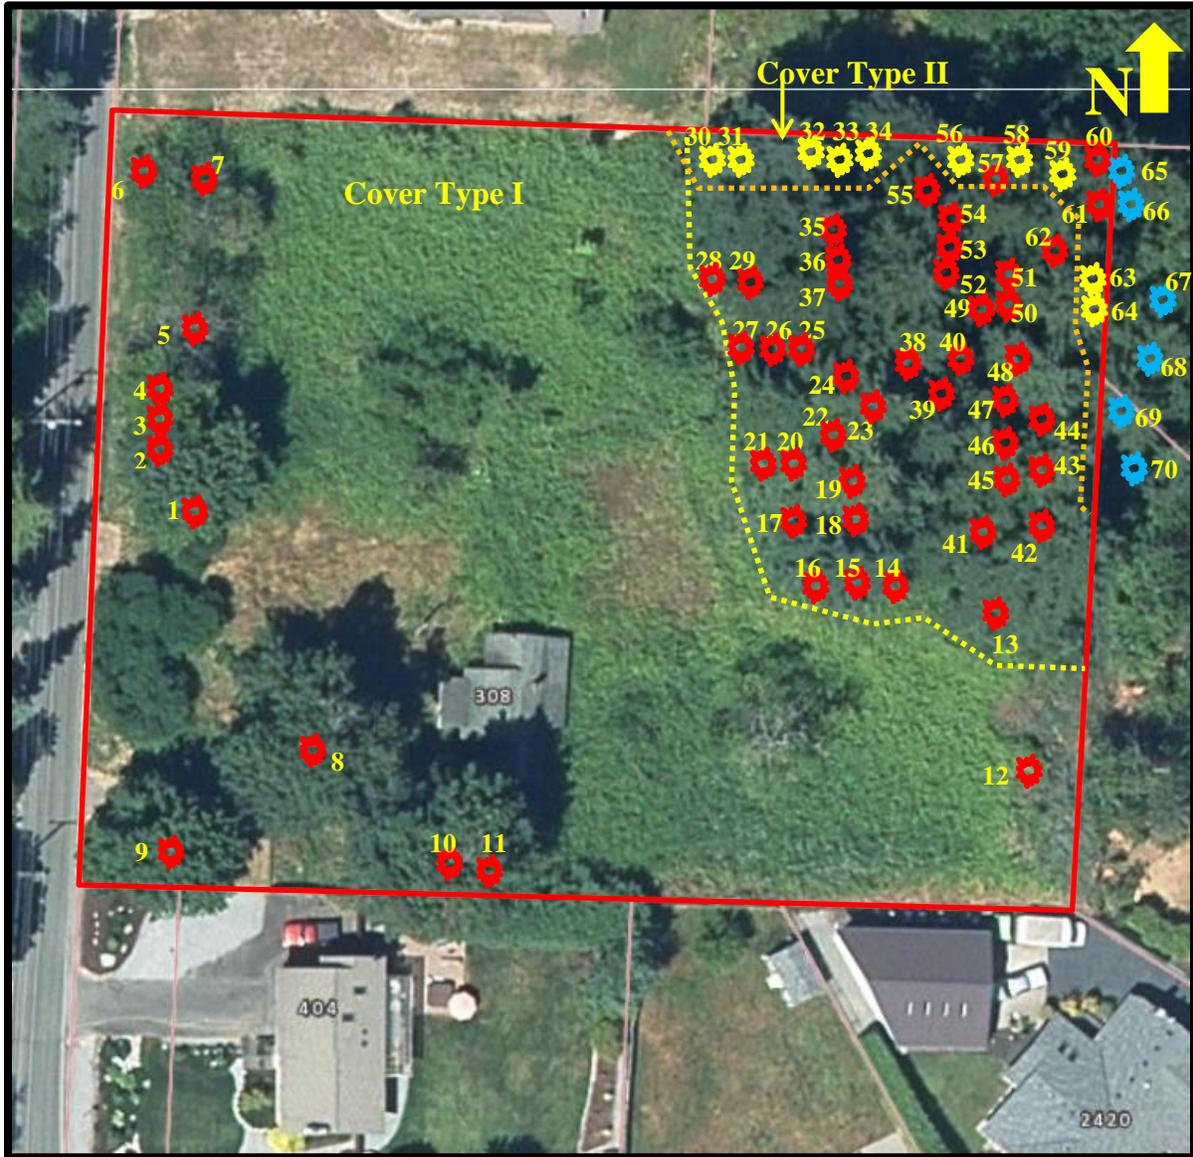
**Attachment 1. Aerial Photo of 308 23<sup>rd</sup> Ave. with Tree Locations Indicated**

There are 6 off-site trees to the east of the project area that occur in a stand that is contiguous with the trees in Cover Type II. They will need to be protected from the impacts of construction if they are to be retained during development. They are described in Table 3. below, and their locations are illustrated on the aerial photo in Attachment 1.

Milton Municipal Code (MMC) requires as many significant trees to be retained as possible. Significant trees that cannot be reasonably retained shall be replaced at a ratio according to their size as described in MMC 17.44.110 G. 4. Ten (10) of the 64 total trees on the site can be retained based on their condition and location on the perimeter of the project area. The locations of these trees are illustrated on the aerial photo in Attachment 1. The following is a summary of our tree retention and replacement requirements.
