CITY COUNCIL MEETING AGENDA
Council Chambers, 1000 Laurel Street

To: Mayor Perry and City Councilmembers
From: Public Works Director Neal
Date: March 3, 2014 Special Meeting
Re: **Alder Street Stormwater Revisions - EMERGENCY**

CITY OF MILTON
DEEP TEST WELL
MILTON, WASHINGTON

CITY OF MILTON
DEEP TEST WELL
MILTON, WASHINGTON
FEBRUARY 2014

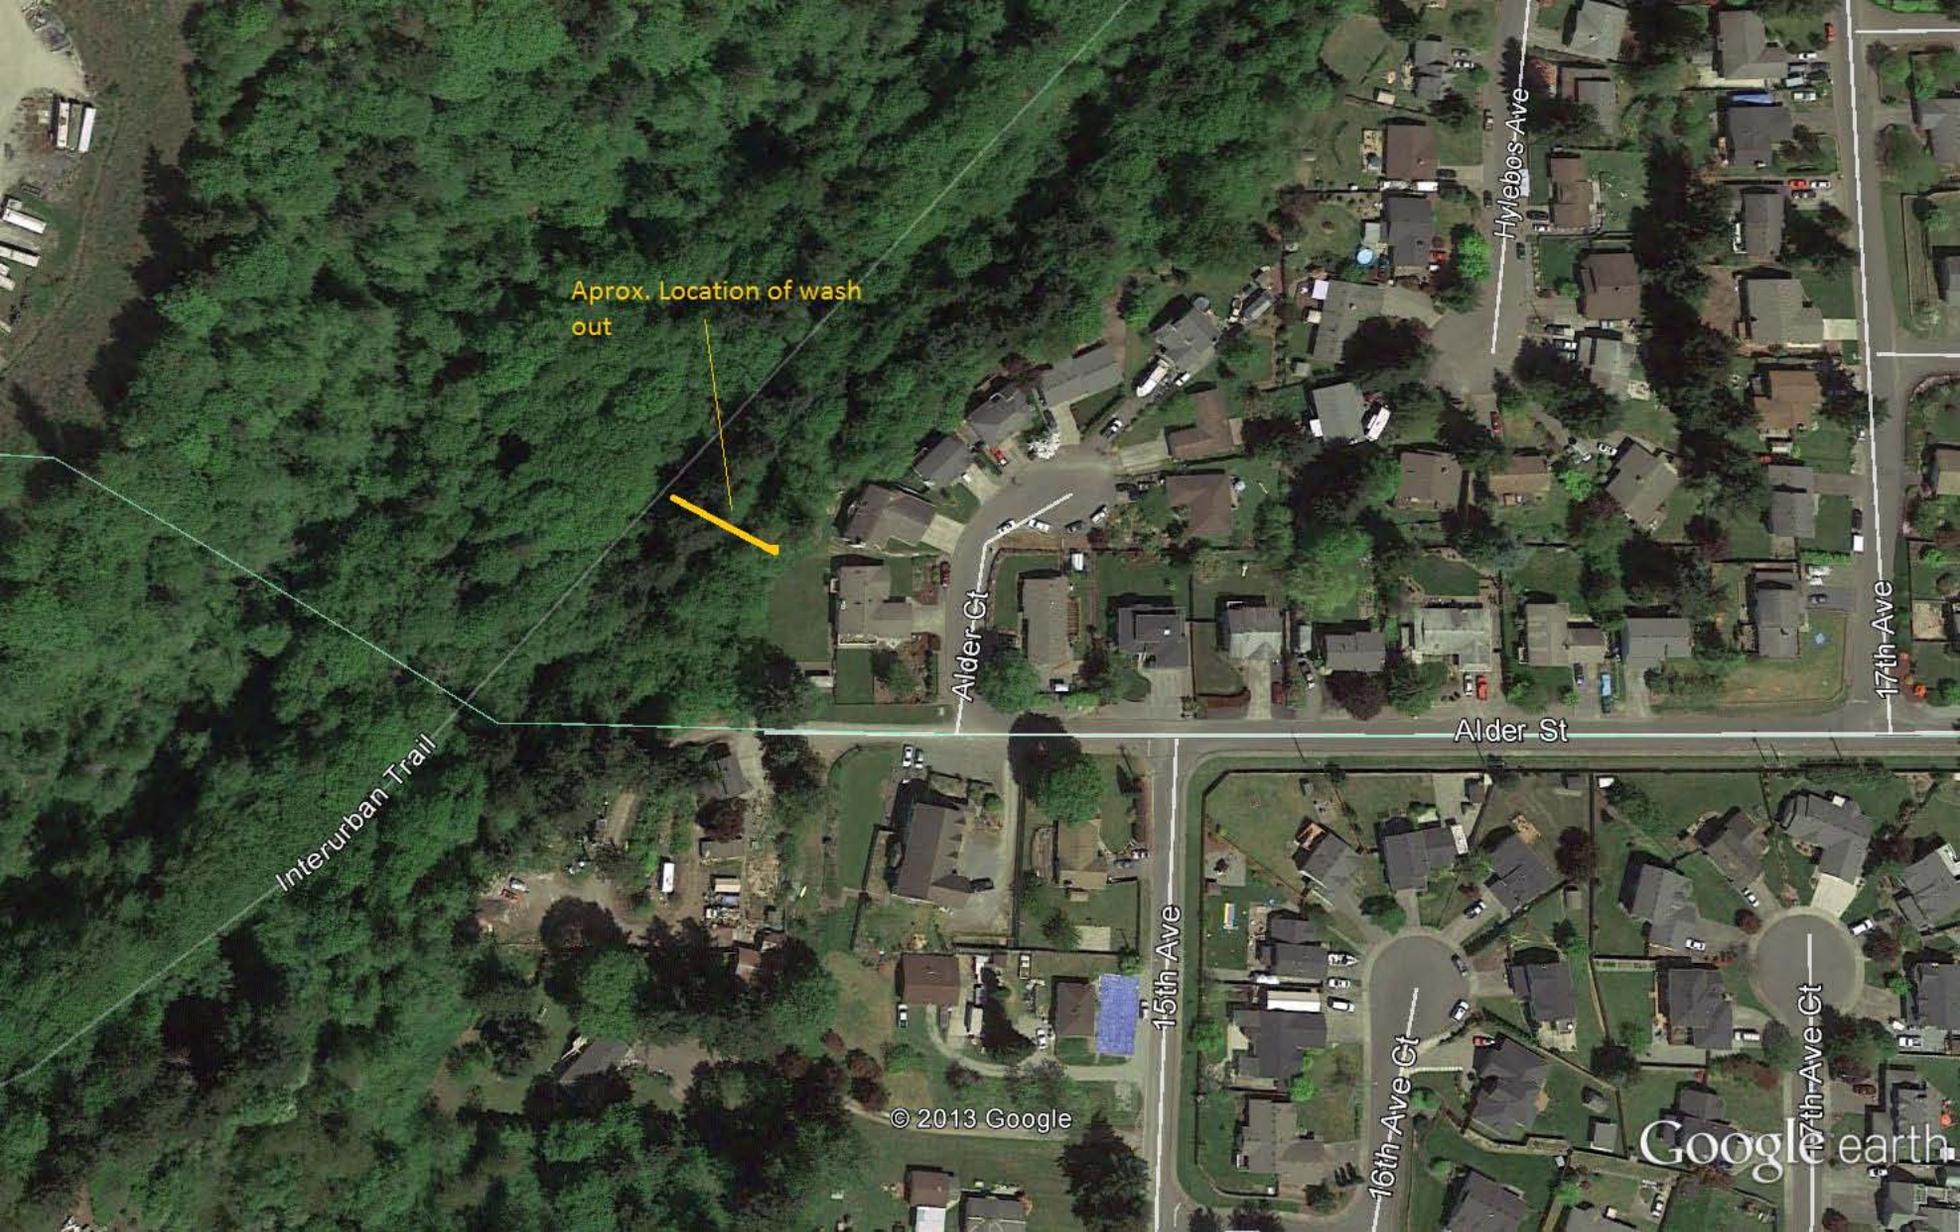
Aprox. Location of wash out

Background: On June 6, 2013, Public Works staff was notified of a possible stormwater issue by property owners at the far western end of Alder Street. A small landslide had occurred where a section of the hill above the Interurban Trail had washed out, and the cause was determined to be a break in a stormwater line. (Refer to Attachment A showing approximate location of washout.)

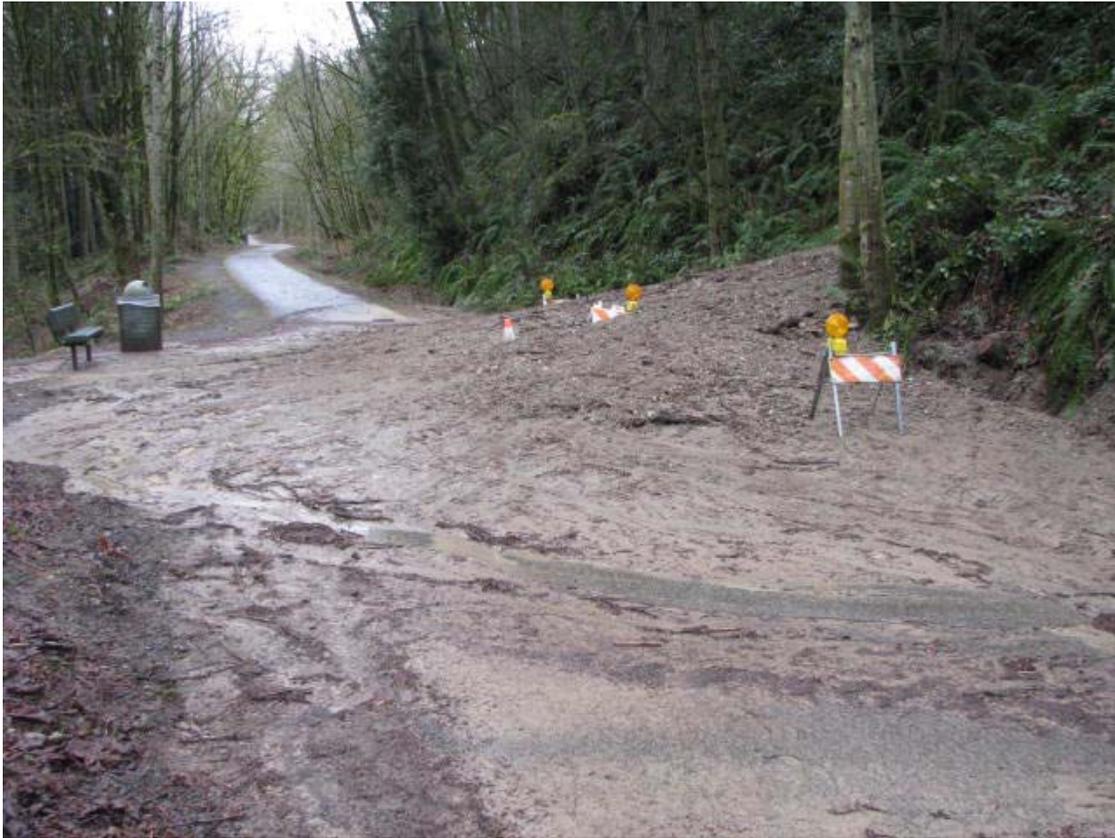
February 17, 2014 mudslide onto Interurban Trail, looking north

On February 17, 2014, the Puget Sound area experienced a major storm event. A significant amount of the hillside at the end of Alder Street washed down onto the Interurban Trail, completely

blocking it. Further material came down on February 18 and February 19. Staff closed both ends of the trail, and were able to clear approximately ½ the width of the trail by February 21st. Concrete retaining blocks had been set to keep more mud from flowing across the trail section, and downed trees have been removed. (Refer to photos in Attachment B.)

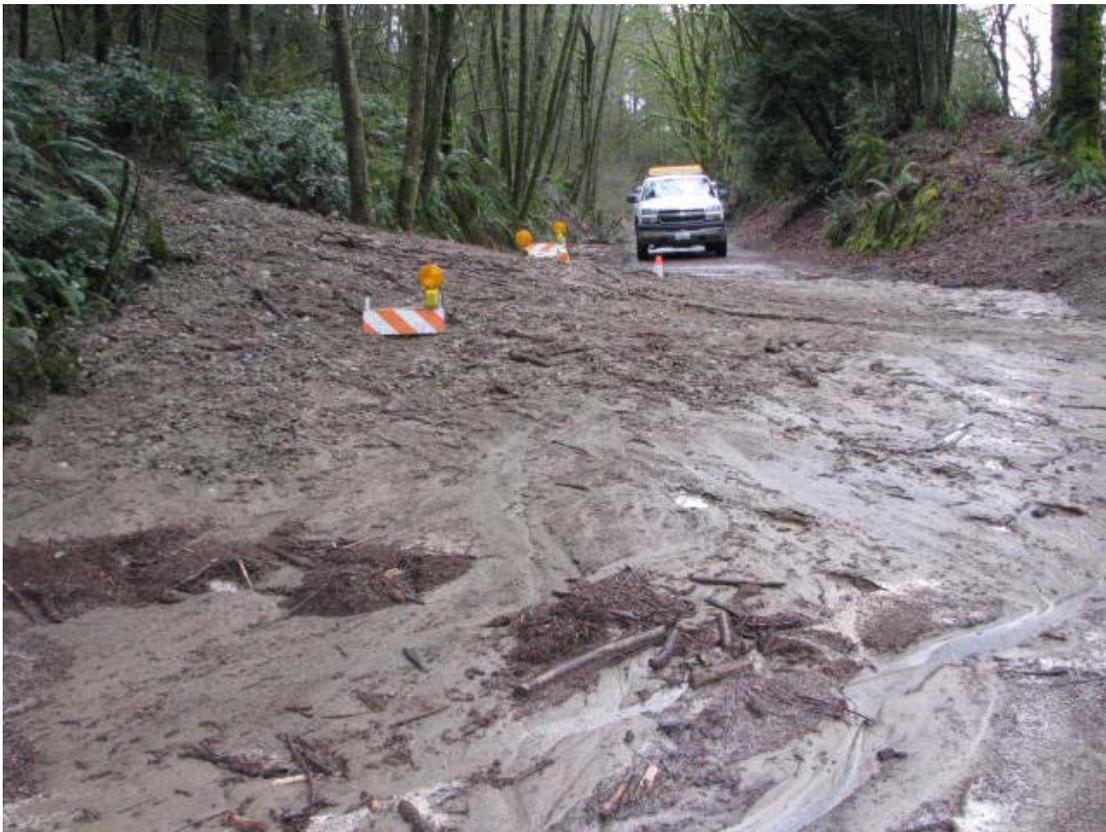
February 17, 2014 mudslide onto Interurban Trail, looking south

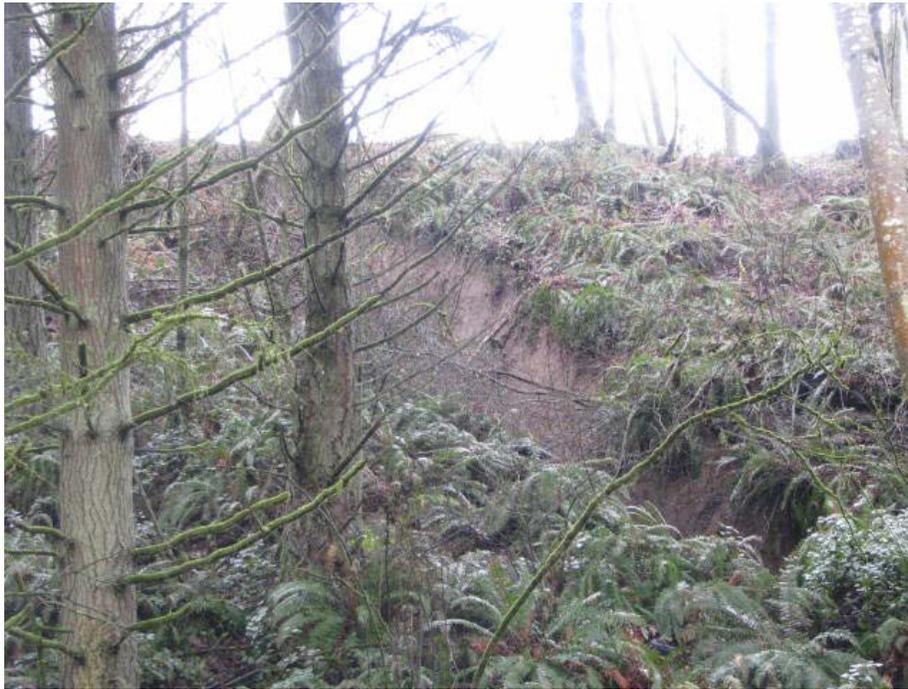
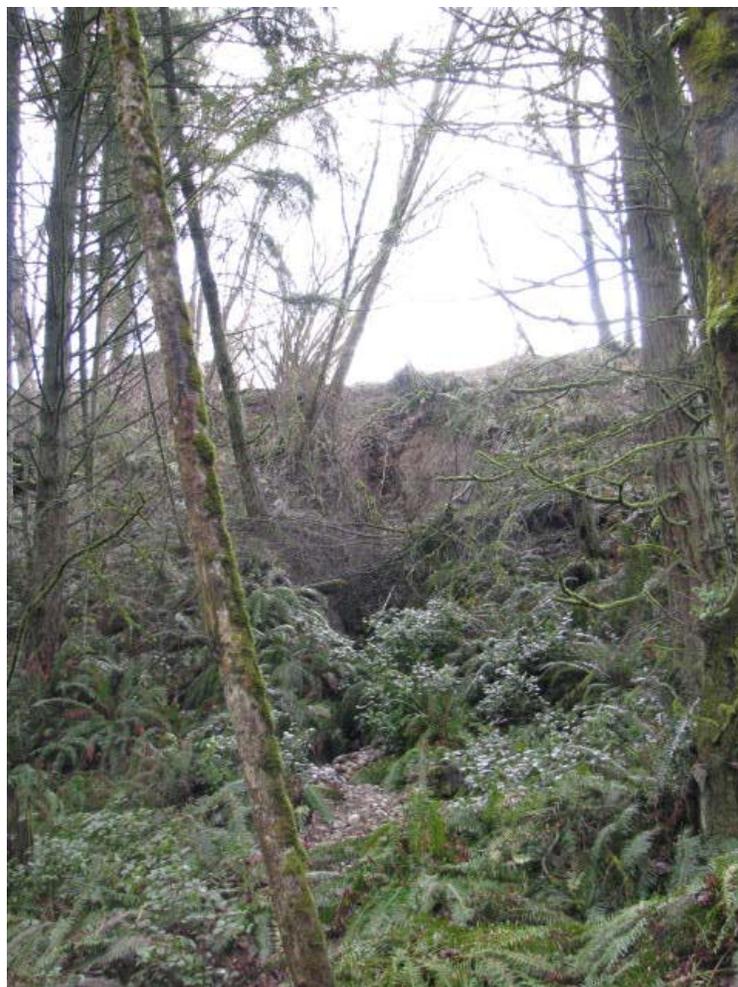
Both photos, the washout on the slope above the Interurban Trail
