PRELIMINARY
STORMWATER SITE PLAN
FOR
GORBUN SUBDIVISION

**PRELIMINARY
STORMWATER SITE PLAN**

GORBUN SUBDIVISION

A portion of the NE ¼ of Section 4, Township 20 North, Range 4 East,
W.M., City of Milton, Pierce County, Washington

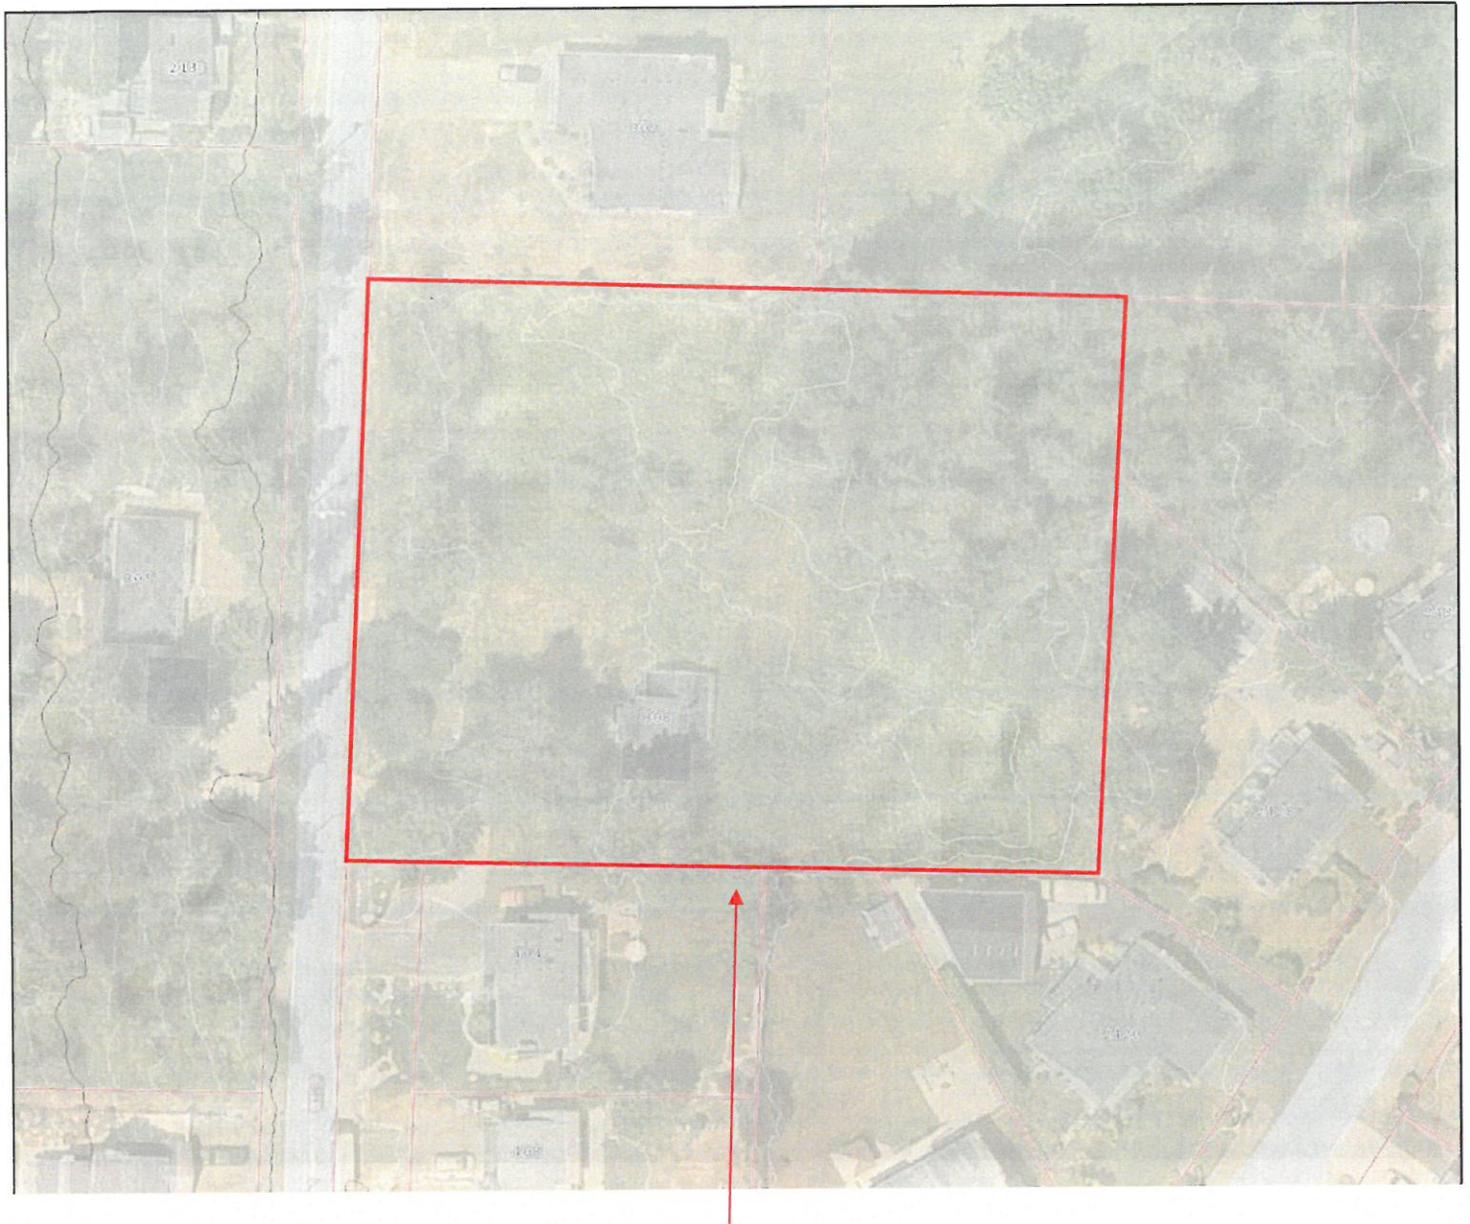
Site Vicinity Map

Approximate Site Location

Map created from Peirce County Public GIS (<https://matterhornwab.co.pierce.wa.us/publicgis/>)

Based on information obtained from the Pierce County Public GIS as well as our site observations, the site generally flat to gently sloping up from west to east at about 3 percent. Total topographic relief across the parcel is on the order of about 6 feet. The existing site configuration and topography is shown on the Site Vicinity Map, Figure 3.

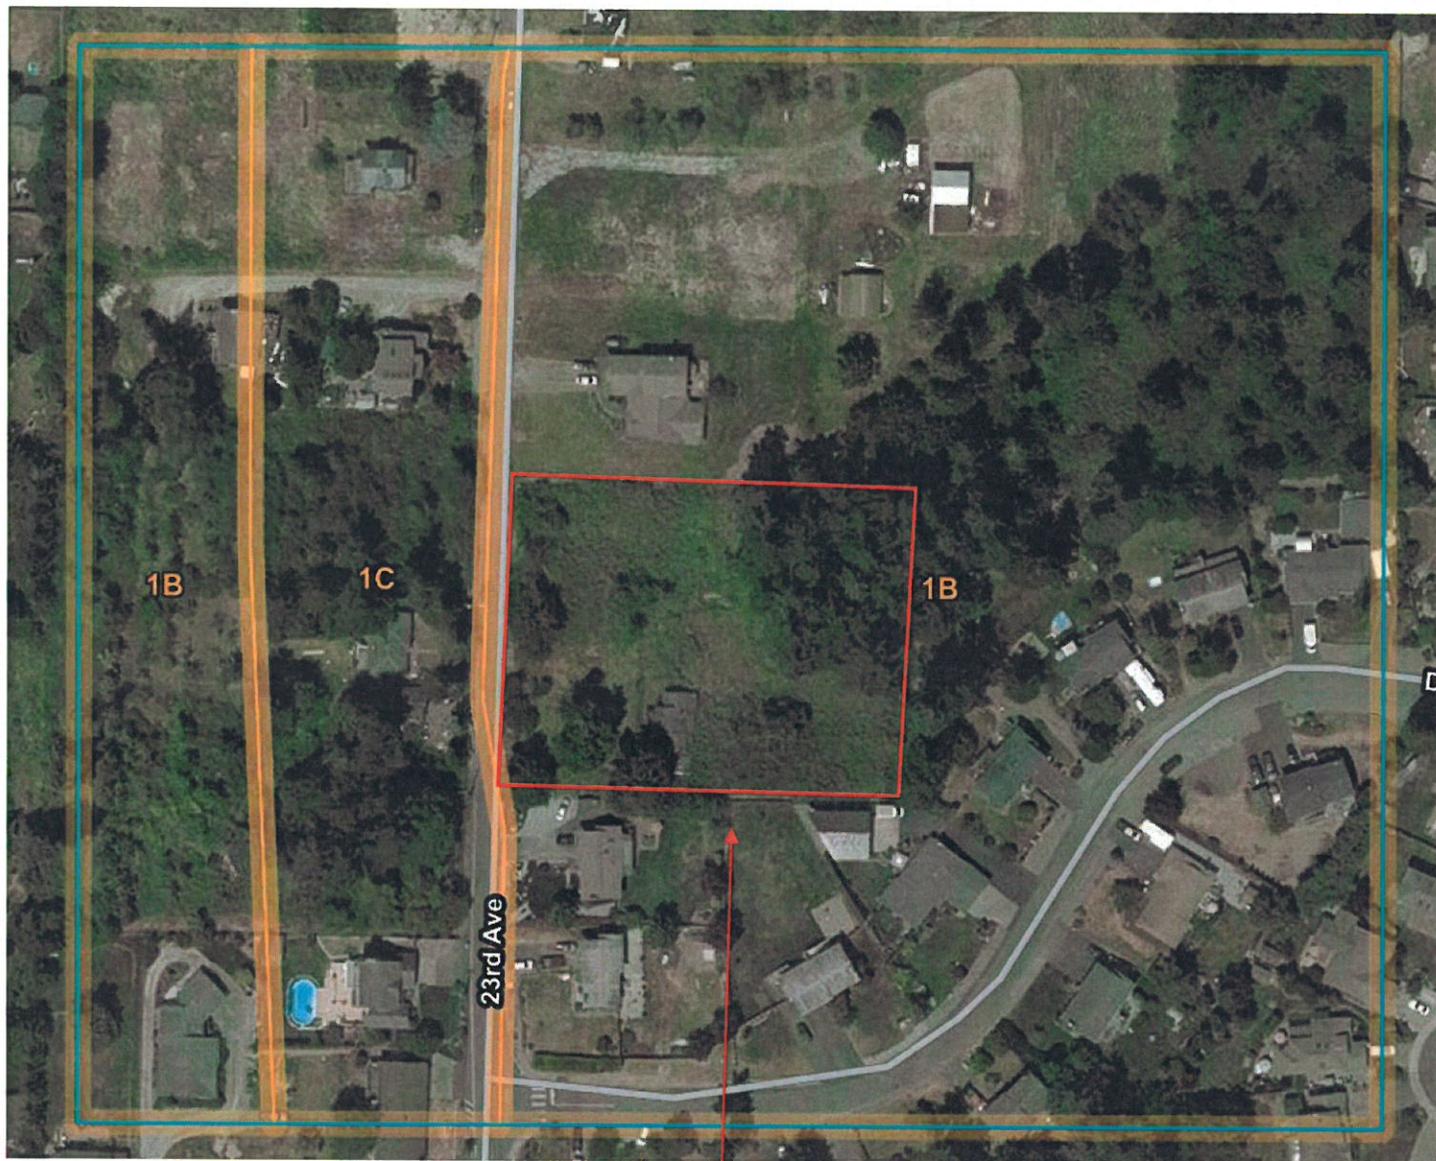
NRCS Soils Map

Approximate Site Location

Map created from Web Soil Survey (<http://websoilsurvey.sc.egov.usda.gov/App/WebSoilSurvey.aspx>)

The USDA Natural Resource Conservation Services (NRCS) Web Soil Survey indicates that the site is underlain by Alderwood gravelly sandy loam (1B) soils. The Alderwood soils are derived from glacial till and form on slopes of 0 to 8 percent. These soils have a “slight” erosion hazard when exposed and are including in hydrologic soils group B. An excerpt of the NRCS soil map for the site vicinity is included as Figure 4.

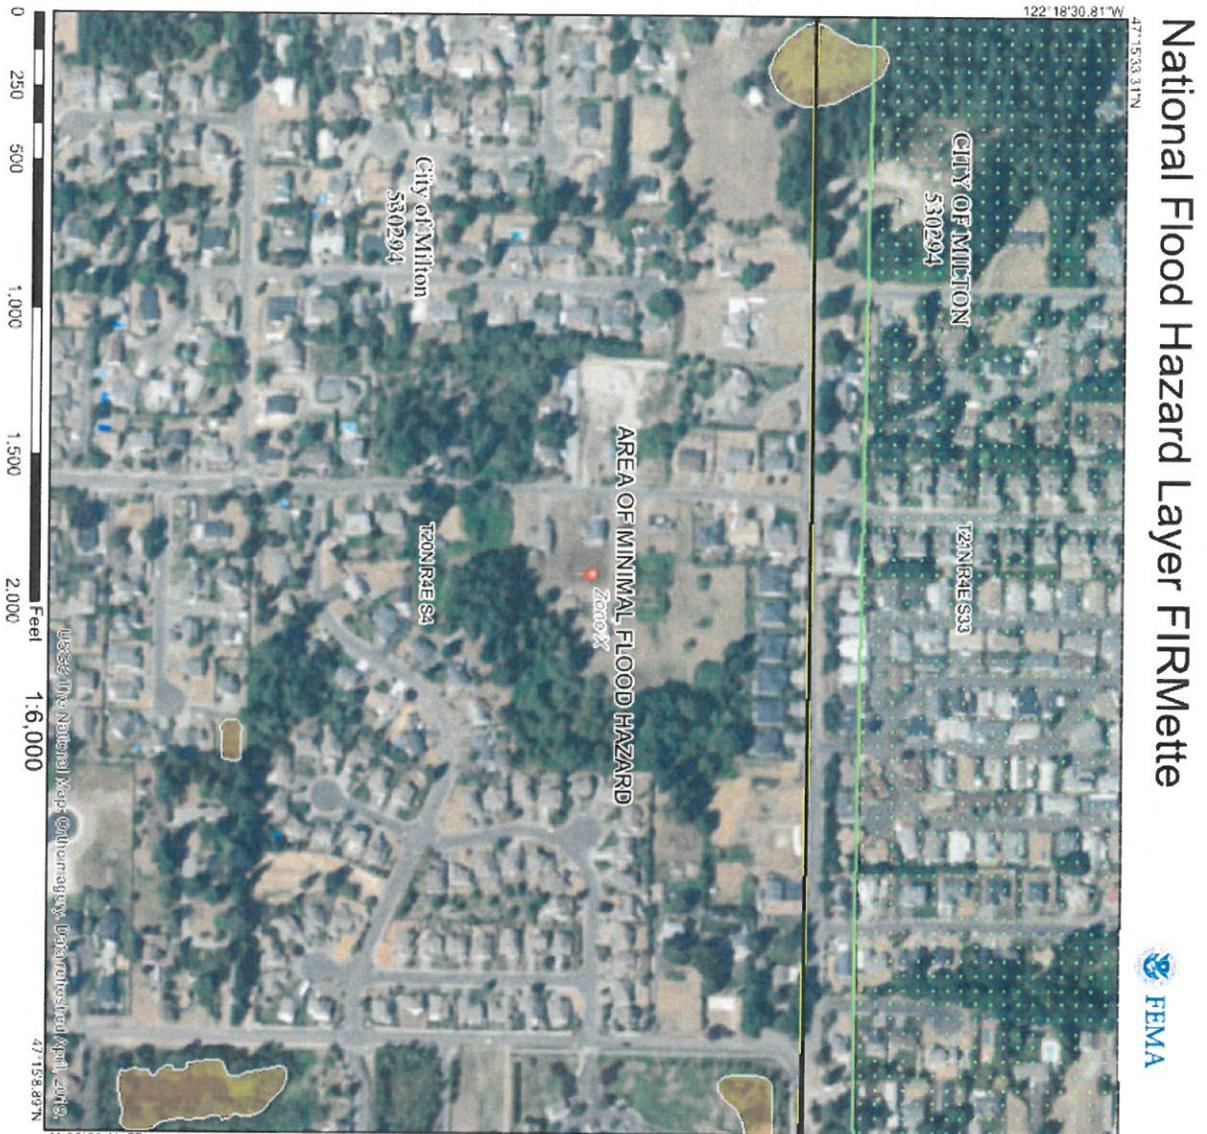
Figure 2.1 – FEMA FIRMap

National Flood Hazard Layer FIRMap

The project is not located in a mapped flood plain. See Figure 2.1 for FEMA FIRM mapping.

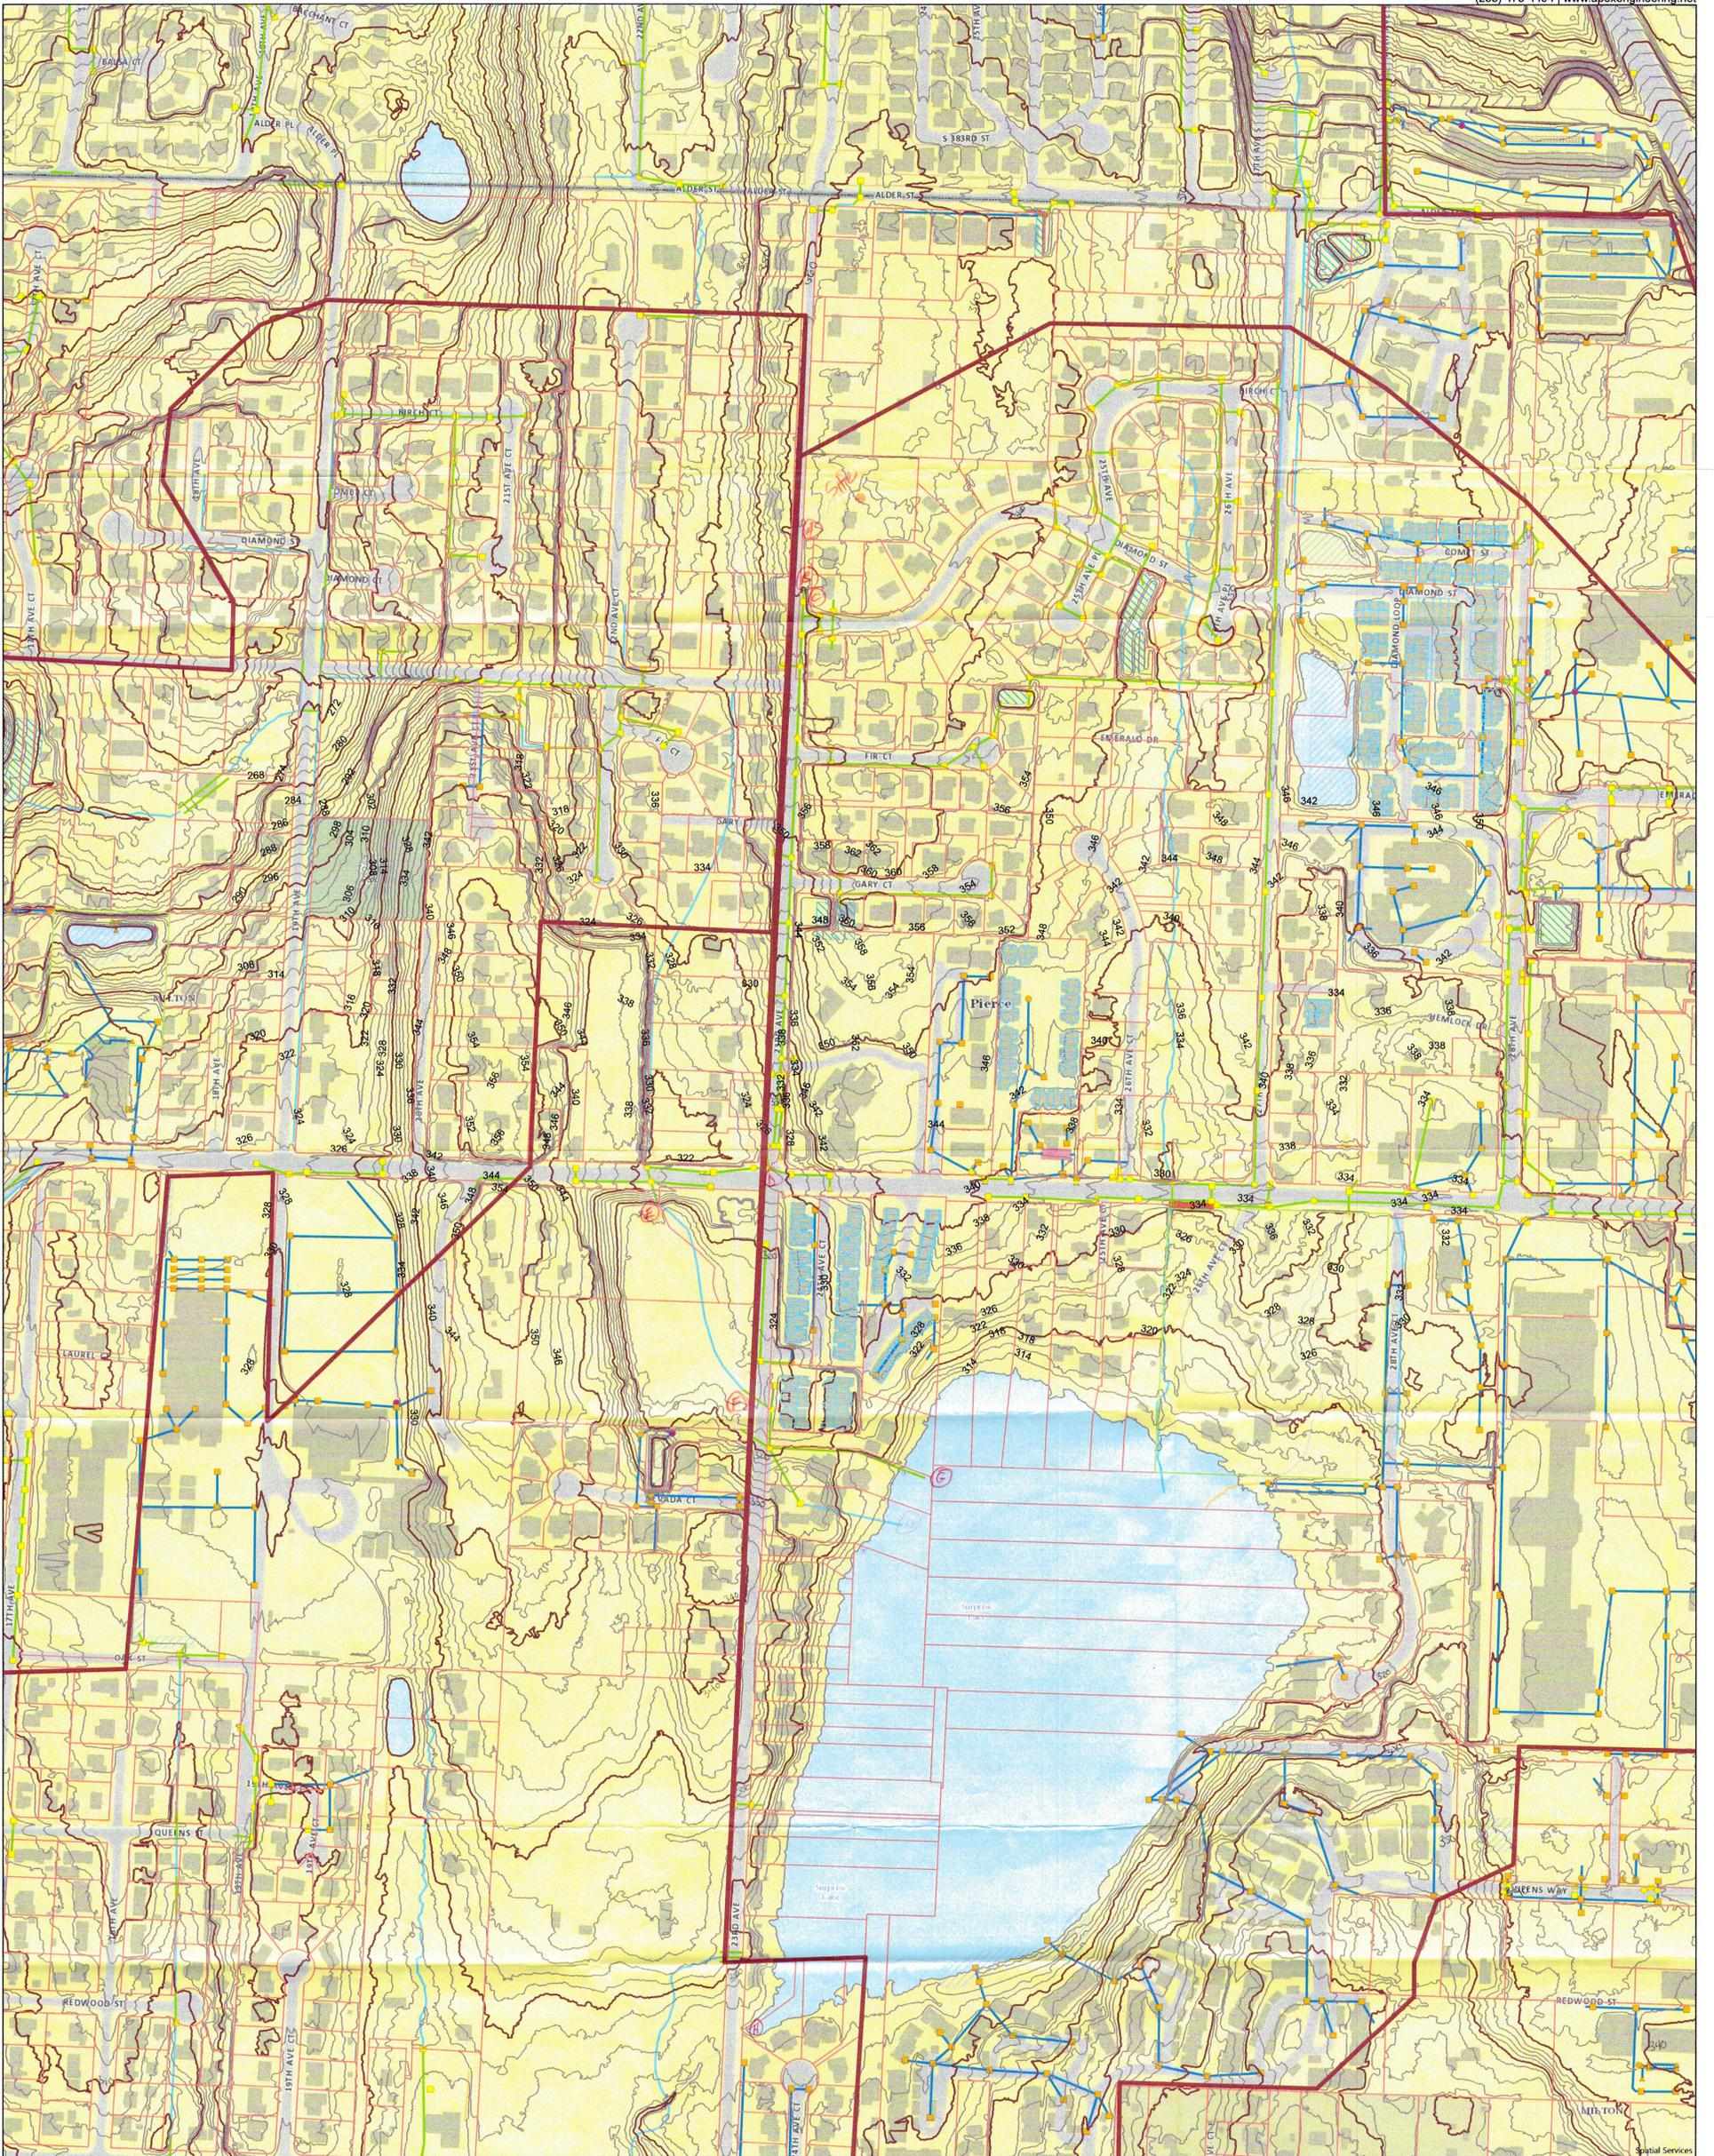
Fig B.1

F	Outlet structure	Concrete structure, inlets water from large well vegetative area.		2650	Filled with sediment	Further sediment build up	blackberry vines. Structure is next to 23 rd Ave and intakes stormwater from the large vegetative area and conveys to Surprise Lake. Structure sump was filled with sediment.
G	Storm outfall	Outfall pipe unknown type and size.		3500	Could not observe	None	Per mapping the existing storm drain system is located with existing private property. Unable to gain access to private property to observe the outfall pipe that extends into Surprise Lake.
H	Culvert pipe	Concrete Culvert unknown size		5000	None	None	Pipe outlets to the west of 23 rd Avenue. Allows water to exist Surprise Lake to a swale that flows to the south towards Taylor Street.
I	Culvert pipe	Concrete pipe unknown size		5420	None	None	Pipe outlets to the south of Taylor Street to a well vegetated and gravel swale with a flat slope that continues to flow to the south.
